Instructions for S11 Maintenance

File Category: Maintenance Plan

Content of this Volume: It mainly describes the troubleshooting of various faults of S11, and how to use the test tool for accurate positioning.

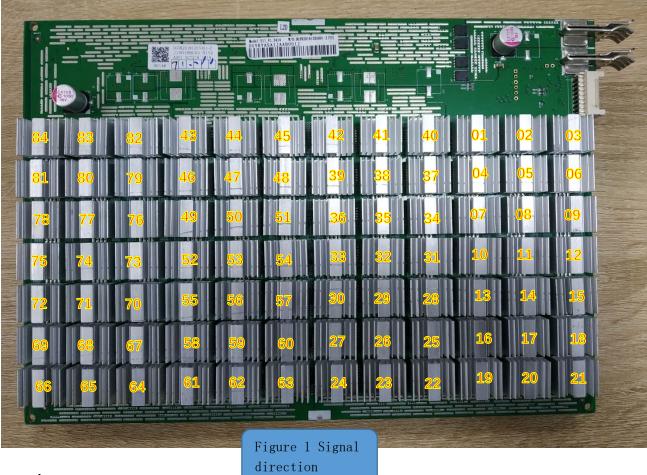
1

There are test points on the PCB chip surfaces. When manufacturing and repairing, if there is no cooling fin attached on the PCB chip, the test point on the chip surface can be used; for repair of finished products (after-sales repair), since the front and back of the PCB are covered by cooling fins, it needs to locate

fault through the test point on the chip surface of the PCB. A special slender test lead can be used to probe the cooling fin gap for measurement. However, since the SMT small cooling fin is connected to the ground of each voltage domain, it is necessary to pay attention to the insulation of the test lead in measurement to avoid short circuit caused by the test lead.

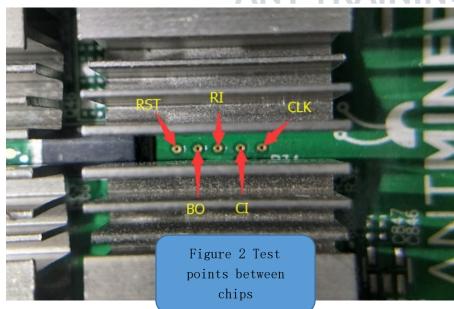
2.2.1 Test points between chips (as shown below after amplified): Figure 2

During maintenance, judge the bad range roughly according to the LOG information prompted by the test jig. The test point between the test chips is the most direct fault location method. The arrangement of the test points of the S11 computing board is:

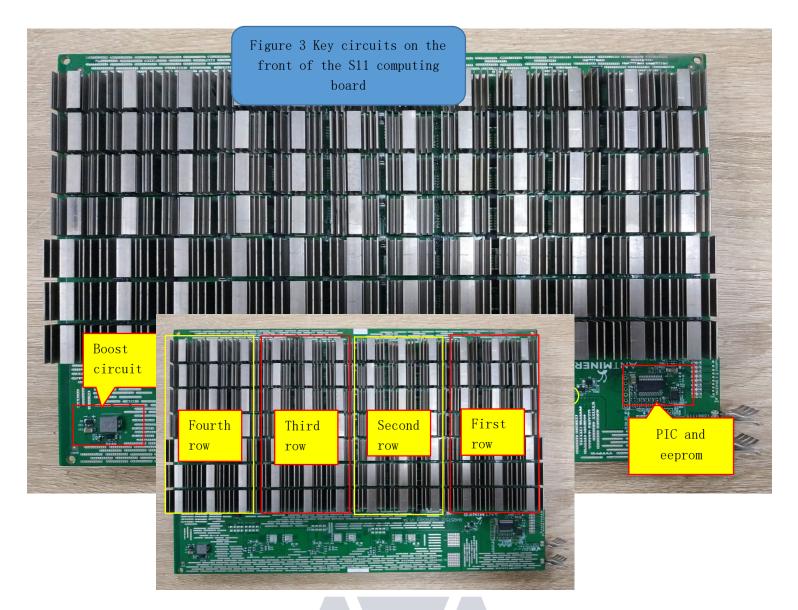
2

The order of the 14 voltage domains in the 2nd and 4th rows (yellow frame) is reversed: RST, B0, RI (RX), C0 (TX), CLK.

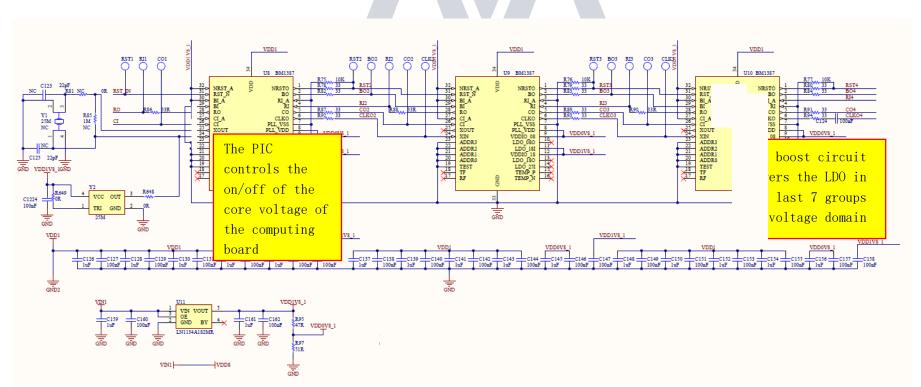
There are 28 voltage domains on the entire board, and each voltage has three chips. The three chips in the same voltage domain are powered in parallel, and are connected with other voltage domains in series after connecting in parallel. The circuit structure is shown in Figure 4 below:

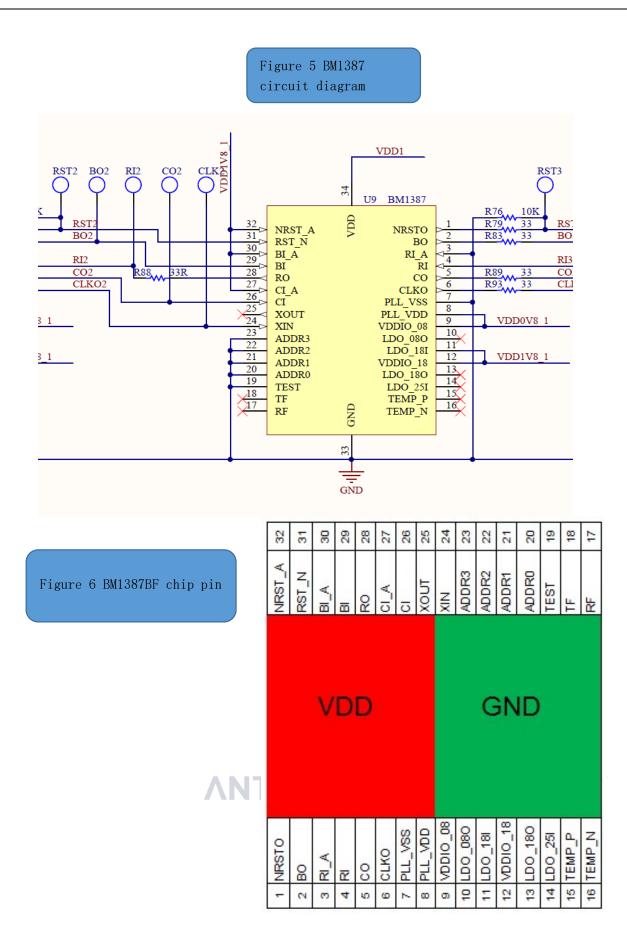
Principle analysis of single chip of voltage domain (see Figure 5 and Figure 6 below):

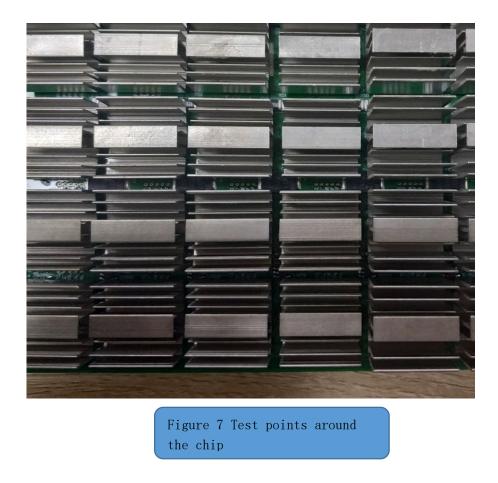
LDO-1.8: 1.8V----When this voltage is abnormal, the chip LDO-1.8O is short-circuited or open circuited, or the peripheral filter capacitor is short-circuited.

PLL-0.8: 0.8V---When this voltage is abnormal, the PLL-08 of a chip in the voltage domain is short circuited or LDO-1.8 is abnormal.

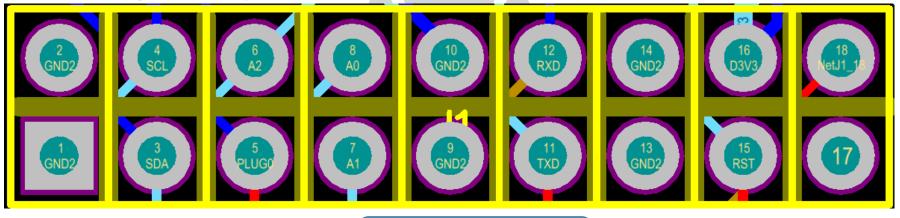
Figure 8 definition of each pin at IO port

The definition of each pin is shown in Figure 8 below:

As shown above:

Pin 16 (D3V3): Powers the computing board 3.3V. The 3.3V is provided by the control board, which mainly supplies the PIC with operating voltage.

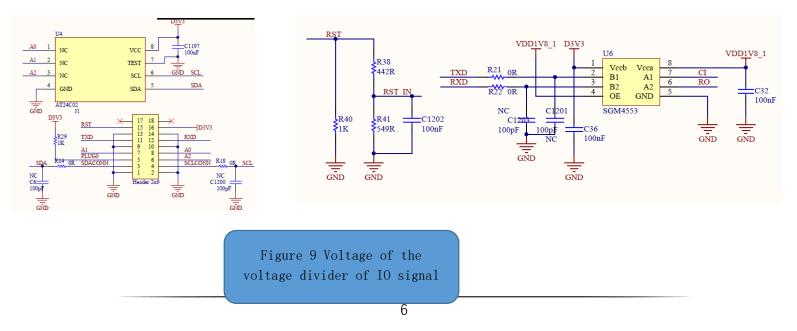
As shown in Figure 9 below, the voltage and distribution of each pin of IO before and after voltage division.

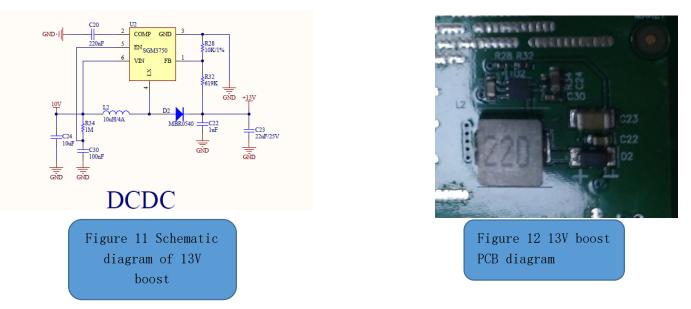
It is responsible for boosting DC-DC (9.8-11V) to 13V. The principle is to boost 9V voltage to 14 V through U2 SGM3750 switching power supply. The switching signal produced by U2 is the energy storage inductor through L2, and then D2 is charges and discharges the C23 to boost rectifier diode, thereby obtaining 13V of the C23 positive electrode. As shown in Figure 11 and Figure 12:

It should be noted that the abnormal rise of the voltage of the boost circuit may easily cause damage to the LDO of the last seven voltage domains of the computing board, and may also cause chip damage.

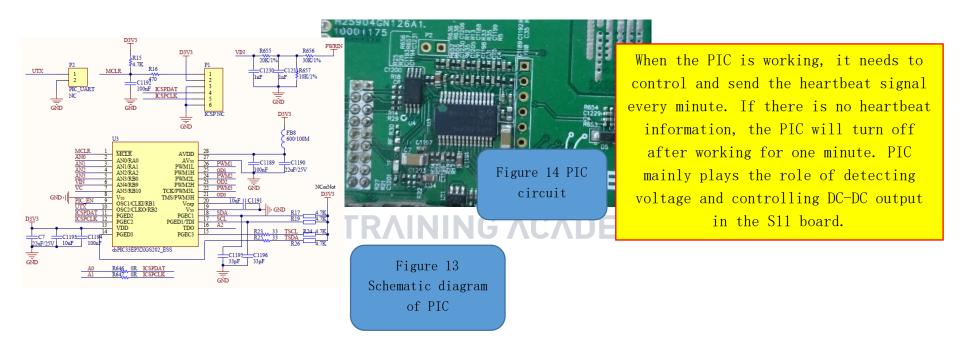
It consists of dsPIC33EPXXGS202_ESS and eeprom. As shown in Figure 13 and Figure 14: A device that stores the frequency information and temperature sensing information of the computing board chip, through which it controls the DC-DC output of the computing board.

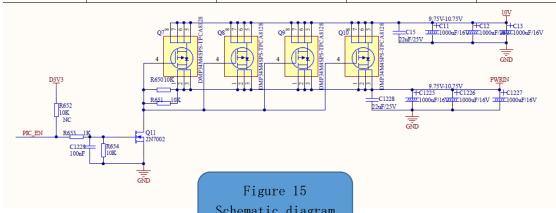
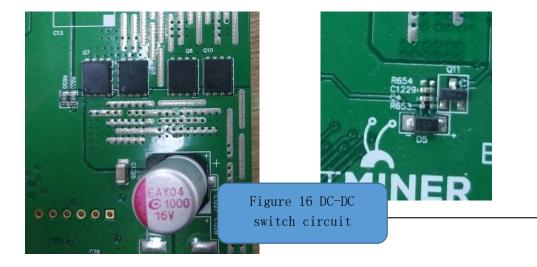
Schematic diagram of DC-DC

It consists of 7002 and 4 CMOS tubes. When PIC_EN outputs a high level, 7002 acts as a switch, and the controlling MOS tube reaches the conducting state on as shown in Figure 15 and Figure 16:

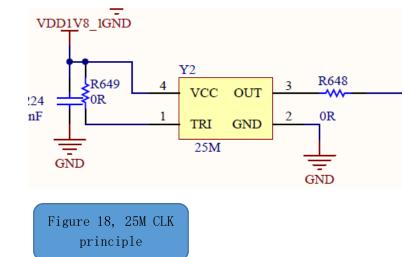
It consists of Y 25MHZ active crystal oscillator and 1.8V power supply: as shown in Figure 17 and Figure 18.

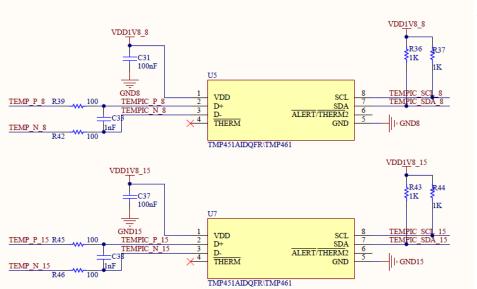
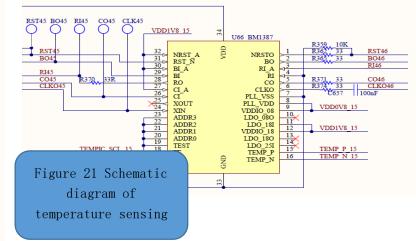
There are two groups of temperature sensor, one is composed of temperature sensor U5 and computing chip U39, and the other is composed of U7 and computing chip U66; the principle of each temperature sensor group: it is the built-in temperature sensor group (15th and 16th pins of BM1387) and temperature sensor, these two temperature sensing parameters are collected and finally passed the 17th and 18th pins of BM1387, and return to the FPGA of the control board through the RI. The principle is shown in Figure 21:

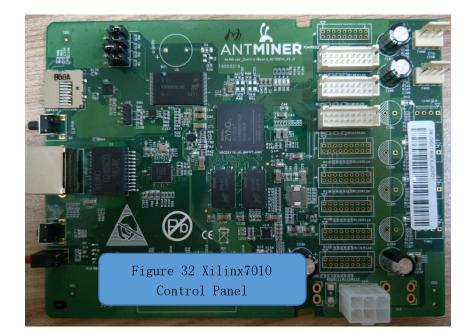
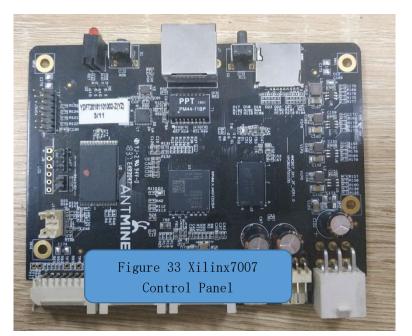
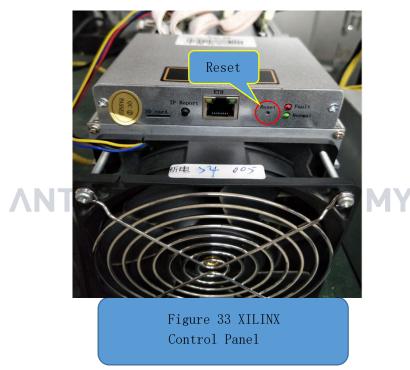
One is the Xilinx 7010 control board, as shown in Figure 32; the other is Xilinx 7007 control board, as shown in Figure 33.

The method of restoring to the factory setting of the control panel is to press the IP Report button for 5 seconds or more when turning on, and then release when the red and green lights flash, and start to restore to the factory setting.
